Essex Healthy Headwaters River Restoration Project

Essex River Walkover Survey 2012

CRF bid - Essex Healthy Headwaters Project

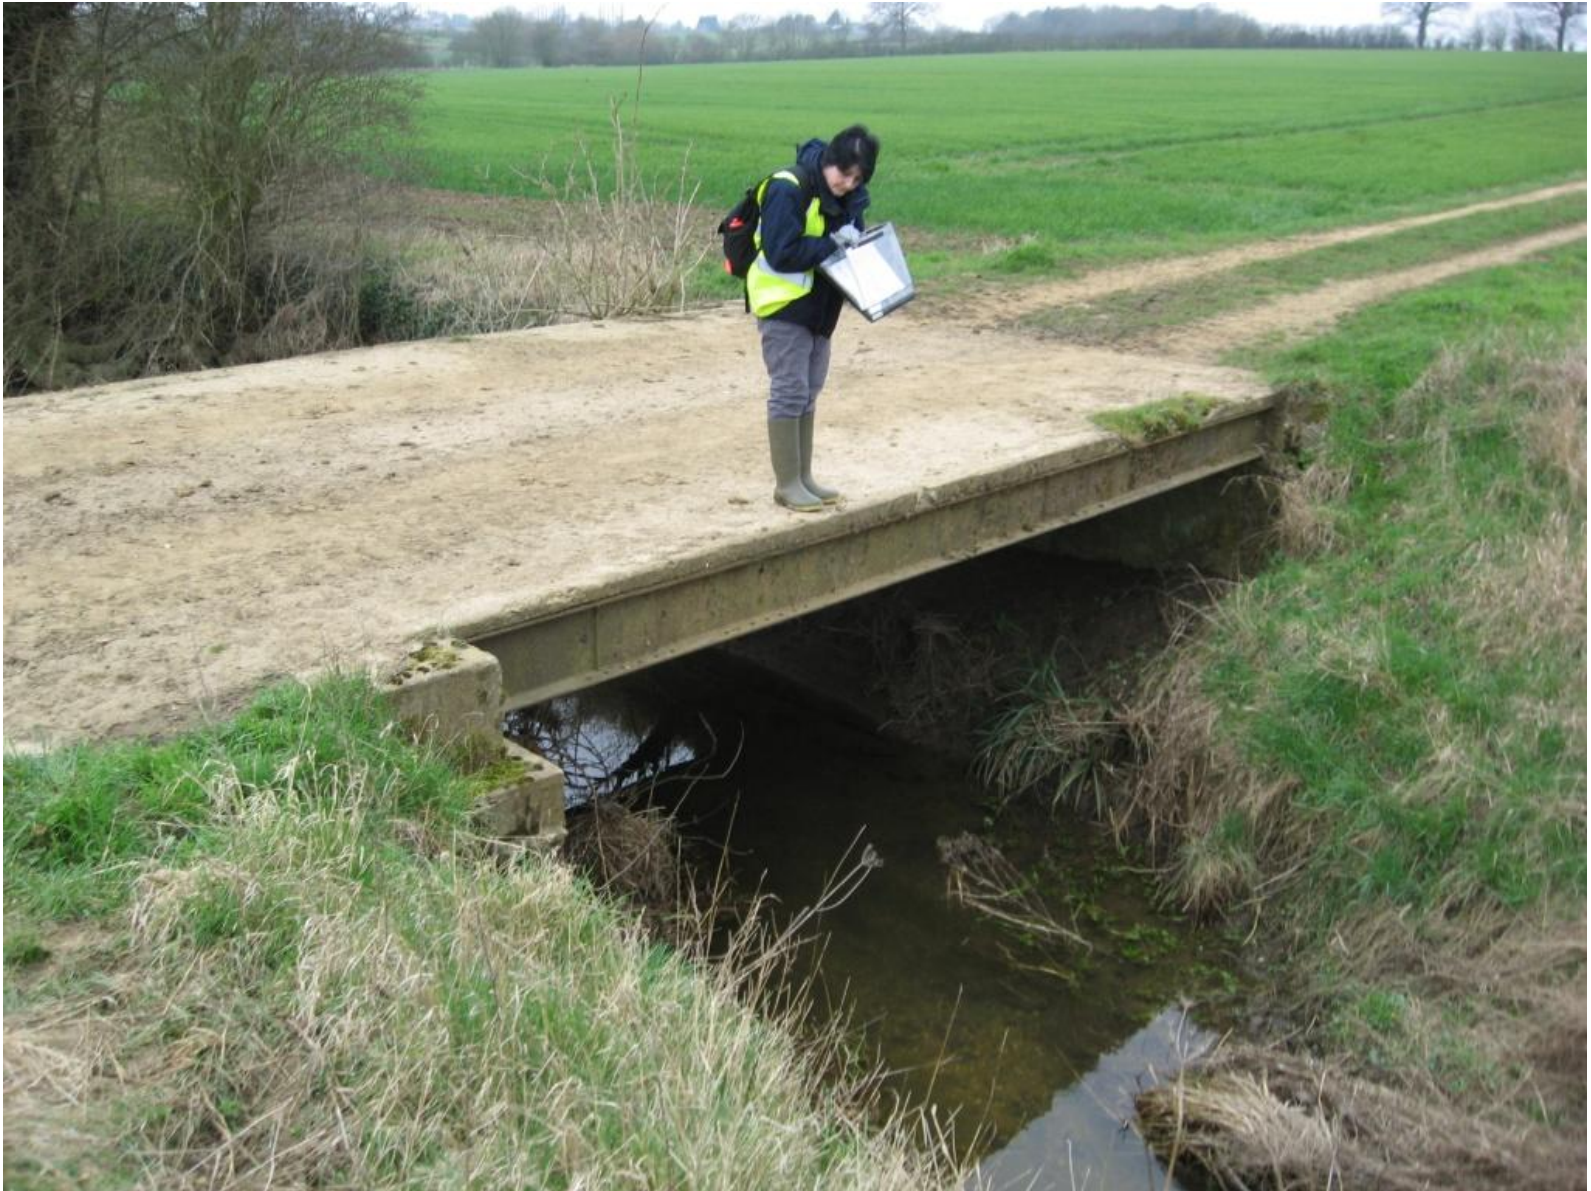
WFD River Colne

500m survey areas
River Colne Upper from
Colchester
to Steeple Bumpstead

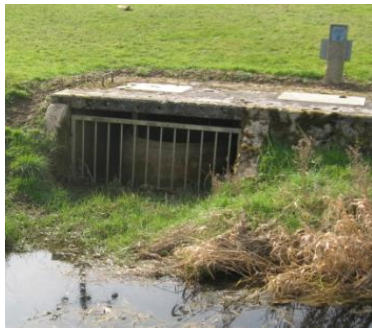
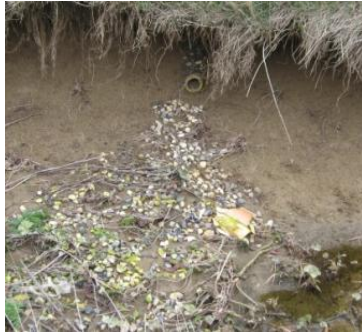
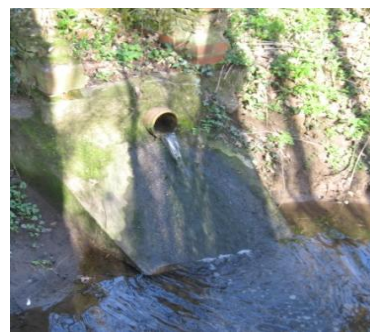
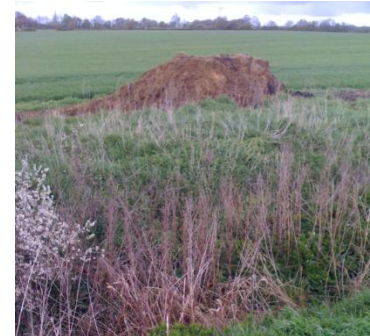
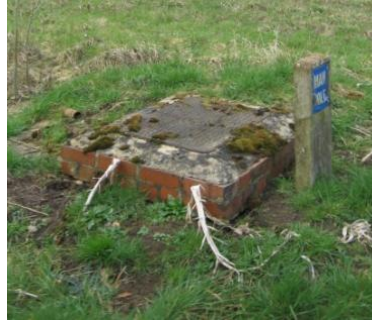
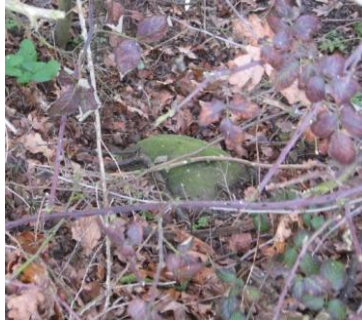
Feature/ sediment source (inc. score)	Grid Ref (6 fig. at least, ideally 8 fig. from GPS)	Comments (inc. photo ref number / name)
Bank slumping typical of river + pipe	TL90150 27381	(29)
Outfall	TL90176 27384	(30) Completely overgrown & undermined
Land drain	TL 90176 90183 27372	(31) Pipe impossible to see, overgrown but flowing under
Reinforced bank	TL90196 27366	(32) Used by sheep to access water
Sheep drink + land drain	TL90206 27361	(33) Pipe & area of poached bank
Outfall	- 11 -	(34) Completely blocked by vegetation
Drain on field boundary	TL90316 27361	(35)
Woody debris	TL90360 27368	(36)
Course Woody debris	TL90408 27365	(37)
Tree in channel & pool	TL90400 27386	(38)
Poaching	TL90399 27407	(39)
Stream side channel	TL90480 27425	(40)
Drainage ditch (flowing)	TL90542 27405	(41)

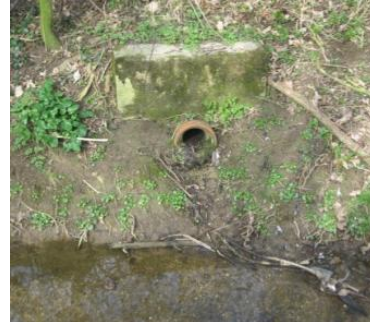
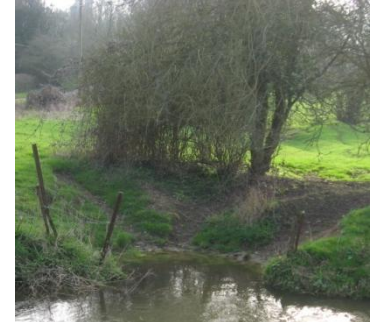
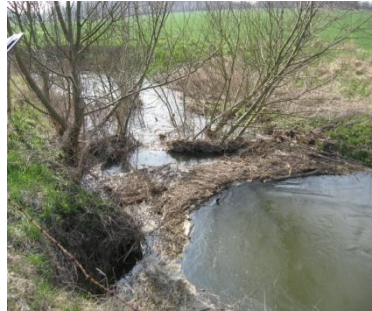
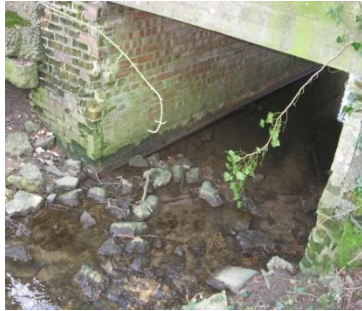
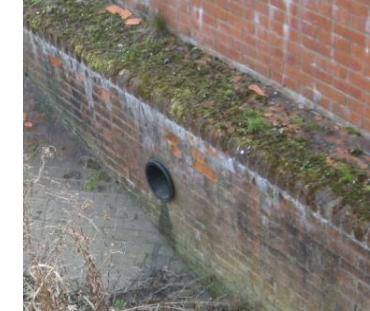
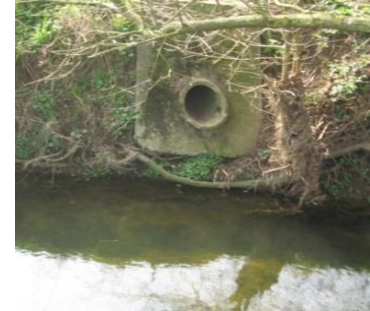
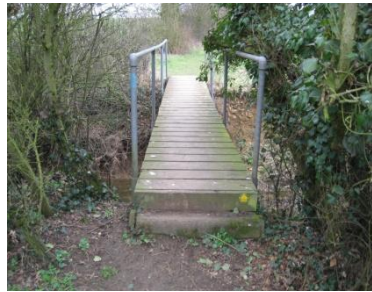
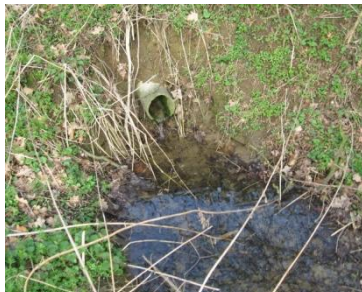
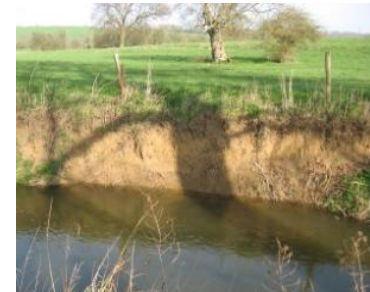
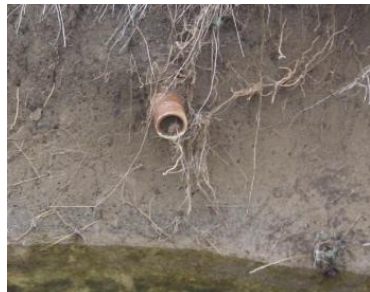
Fragment of
Walkover paper
survey form

WFD Waterbody ID: River name: River Colne Bacon's Farm + Wick Farm (3)
 Date: 30/9/12 Surveyor: DC + JH

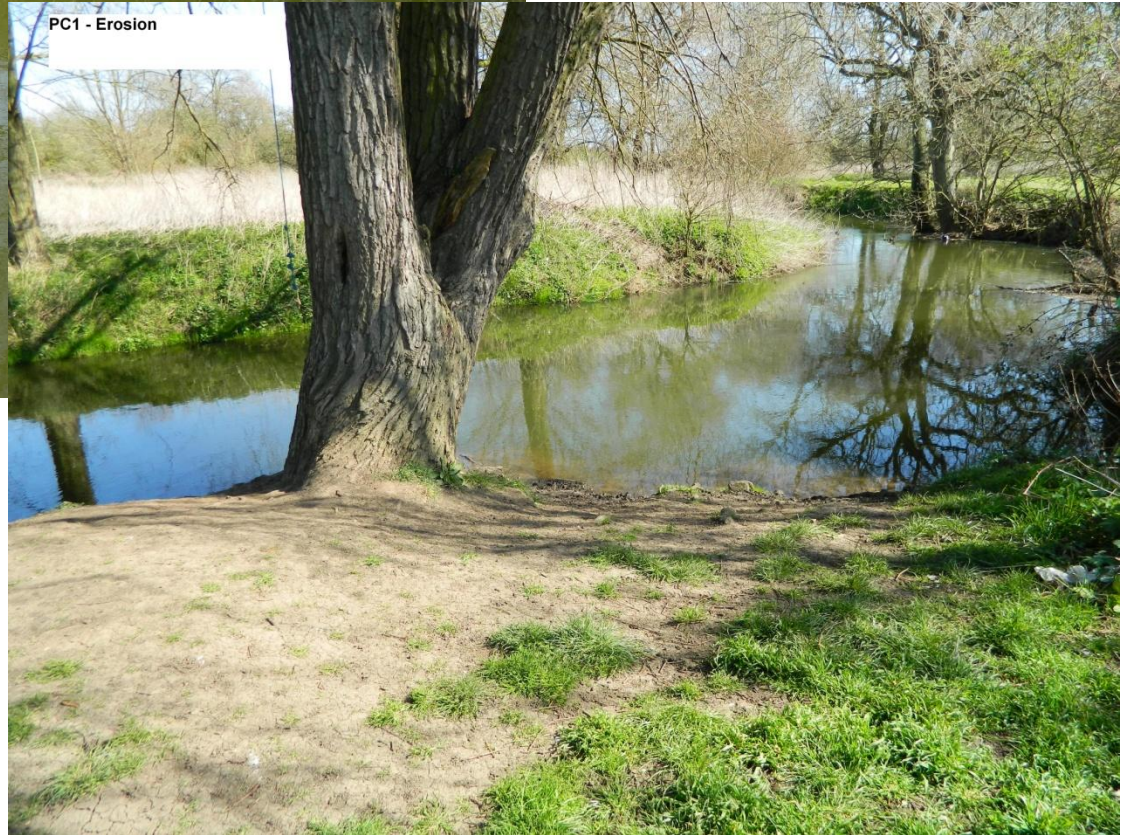
PC1 - Erosion

Photograph of each
potential project site
